Inspection Report

Property Address:
1234 Slick Lane
Chicago, Il.

Inspectrum Inc.

Inspection Date: 4/13/2009
Report ID: 123456

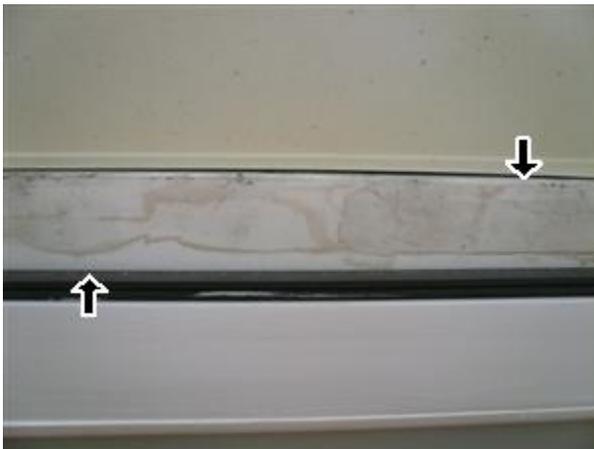
2.10 Picture 1 TOP

MOISTURE STAINING EVIDENT ALONG THE TOP AND WEST SIDE JAMBS OF THE MASTER BEDROOM. BALCONY DOOR. INQUIRE INTO CAUSE AND HAVE REPAIRED.

2.10 MOISTURE STAINING EVIDENT ALONG THE TOP AND WEST SIDE JAMBS OF THE MASTER BEDROOM. BALCONY DOOR. INQUIRE INTO CAUSE AND HAVE REPAIRED.

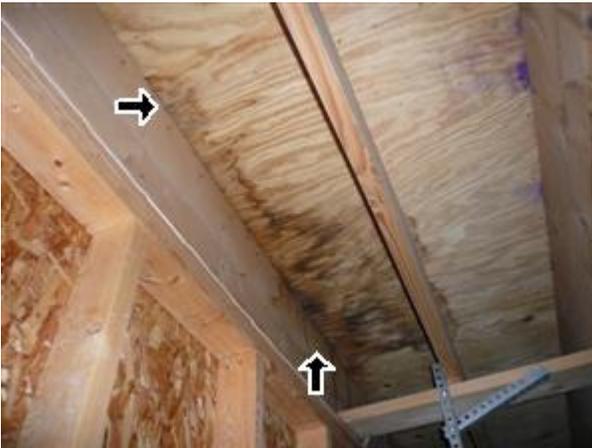
9.11 Picture 1

MOISTURE STAIN (TESTED CURRENT WITH METER) EVIDENT ON THE CEILING ALONG THE EAST WALL. INQUIRE INTO THE CAUSE AND REPAIR ISSUE

9.11 MOISTURE STAIN (TESTED CURRENT WITH METER) EVIDENT ON THE CEILING ALONG THE EAST WALL. INQUIRE INTO THE CAUSE AND REPAIR ISSUE

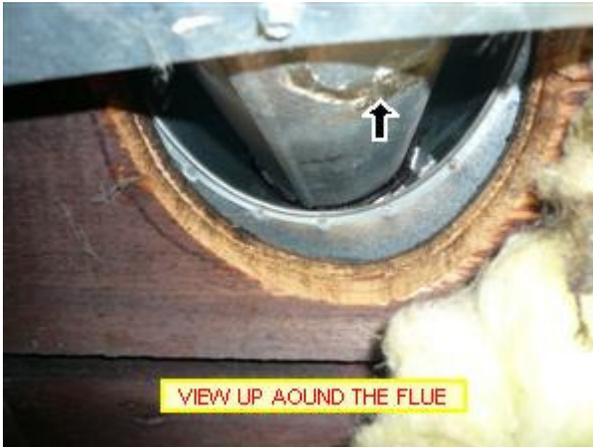
17.8 Picture 1

THERE IS A SMALL LEAK AROUND THE FURNACE FLUE PIPE. THE ARROW POINTS TO RUST ON THE FLUE AND THE INSULATION WAS WET. ALSO THE ATTIC INSULATION SHOULD NOT TOUCH THE HOT FLUE, CHARRED MATERIAL PULLED AWAY AT INSPECTION.

17.8 THERE IS A SMALL LEAK AROUND THE FURNACE FLUE PIPE. THE ARROW POINTS TO RUST ON THE FLUE AND THE INSULATION WAS WET. ALSO THE ATTIC INSULATION SHOULD NOT TOUCH THE HOT FLUE, CHARRED MATERIAL PULLED AWAY AT INSPECTION.

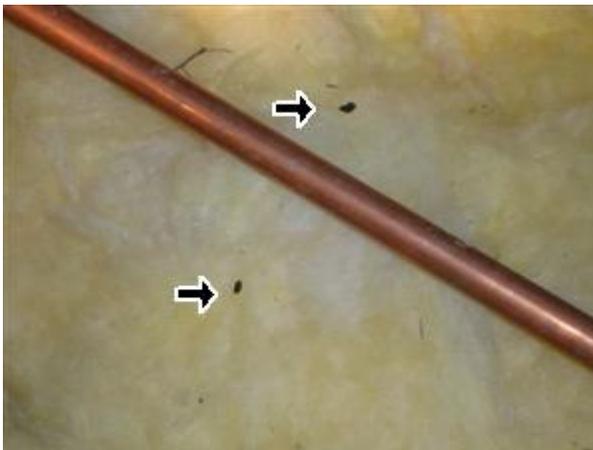
17.11 Picture 1

MOUSE DROPPINGS EVIDENT ON THE INSULATION IN THE ATTIC. REPAIR AS NEEDED.

17.11 MOUSE DROPPINGS EVIDENT ON THE INSULATION IN THE ATTIC. REPAIR AS NEEDED.

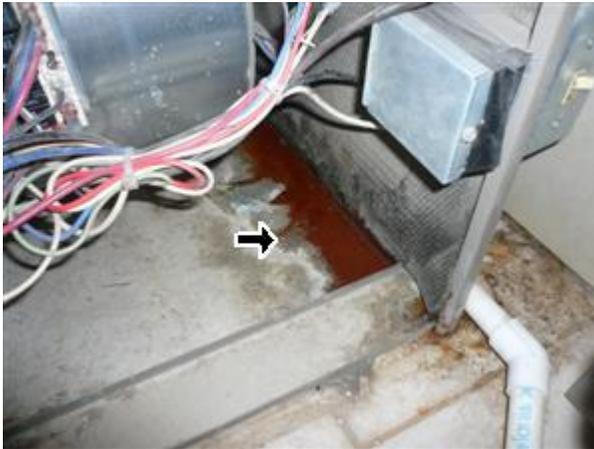
19.0.A Picture 1

- THERE IS LEAKING EVIDENT ALONG THE EAST SIDE OF THE FURNACE. HAVE UNIT SERVICED TO REPAIR.
- RECOMMEND INSULATING THE A/C SUCTION LINE TO THE FURNACE JACKET.

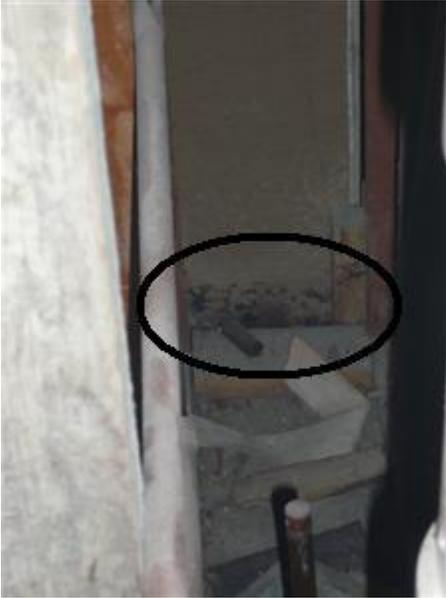
21.10 Picture 1

THERE IS MOLD EVIDENT ALONG THE BOTTOM OF THE WALL (FACES WEST) BEHIND THE WATER HEATER. INQUIRE INTO THE CAUSE AND REPAIR.

21.10 THERE IS MOLD EVIDENT ALONG THE BOTTOM OF THE WALL (FACES WEST) BEHIND THE WATER HEATER. INQUIRE INTO THE CAUSE AND REPAIR.
