Inspection Report

Property Address:
1234 Slick Lane
#2
Chicago, IL

Inspectrum Inc.

Inspection Date: 10/7/2009
Report ID: 123456

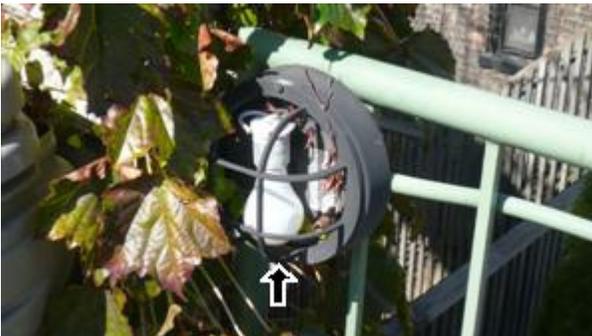
1.5 Picture 1

REPLACE THE MISSING LIGHT COVER AND BAD BULB.

1.5 REPLACE THE MISSING LIGHT COVER AND BAD BULB.

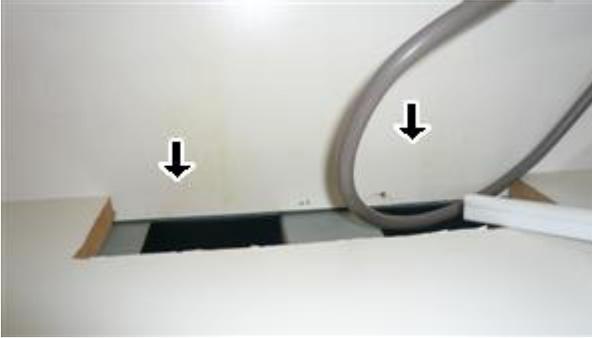
3.23 Picture 1

THE MICROWAVE IS SET TO VENT OUT THROUGH THE TOP BUT NO DUCT WORK IS INSTALLED, CORRECT.

3.23 THE MICROWAVE IS SET TO VENT OUT THROUGH THE TOP BUT NO DUCT WORK IS INSTALLED, CORRECT.

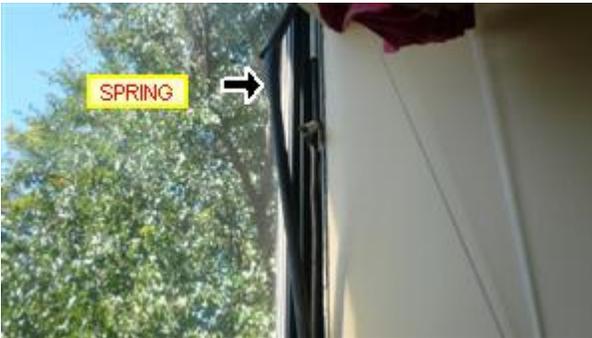
5.4.A Picture 1

THE UPPER RIGHT SASH HAS A BROKEN THERMAL SEAL AND SPRING, HAVE REPAIRED.

5.4.A THE UPPER RIGHT SASH HAS A BROKEN THERMAL SEAL AND SPRING, HAVE REPAIRED.

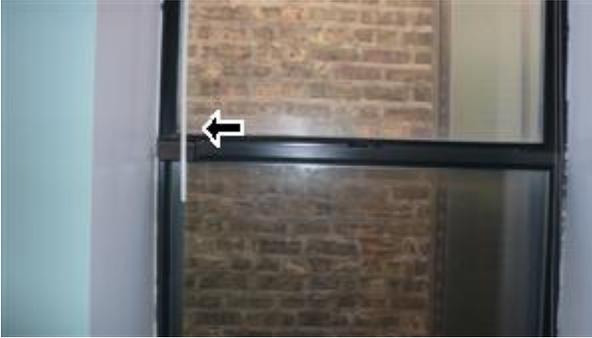
5.4.C Picture 1

REPLACE THE BROKEN LEFT SIDE SASH CLIP FOR THE WEST END WINDOW.

5.4.C REPLACE THE BROKEN LEFT SIDE SASH CLIP FOR THE WEST END WINDOW.

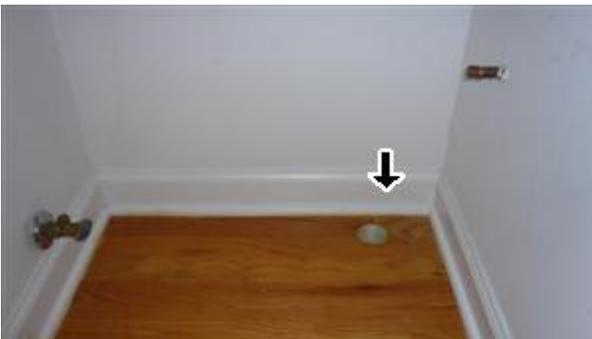
6.2 Picture 1

INQUIRE INTO THE DRAIN IN THE CLOSET. A DRY TRAP MAY ALLOW SEWER GAS INTO THE HOME, ENSURE THE TRAP FOR THE DRAIN IS FULL OF WATER.

6.2 INQUIRE INTO THE DRAIN IN THE CLOSET. A DRY TRAP MAY ALLOW SEWER GAS INTO THE HOME, ENSURE THE TRAP FOR THE DRAIN IS FULL OF WATER.

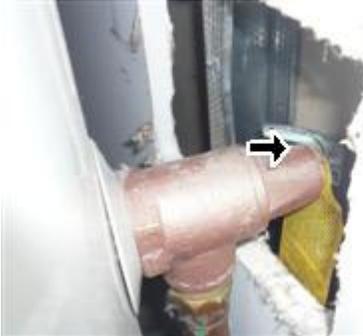
10.3 Picture 1

DUE TO ITS LOCATION AGAINST A WALL, THE TPRV WILL NOT BE ABLE TO RELEASE IN AN EMERGENCY - HAZARD, CORRECT.

10.3 DUE TO ITS LOCATION AGAINST A WALL, THE TPRV WILL NOT BE ABLE TO RELEASE IN AN EMERGENCY - HAZARD, CORRECT.
